Test Report

Inwards opening PVC window with ventilation slat

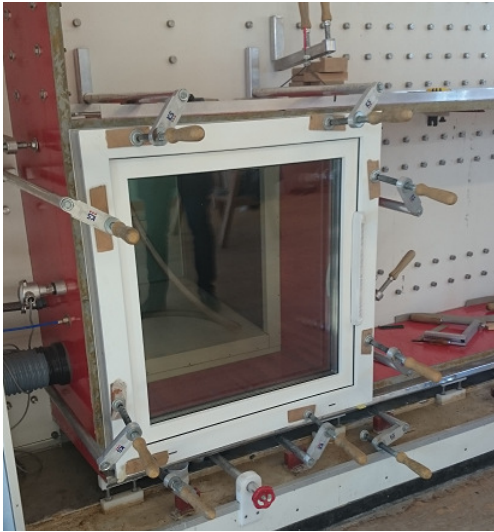
View from outside

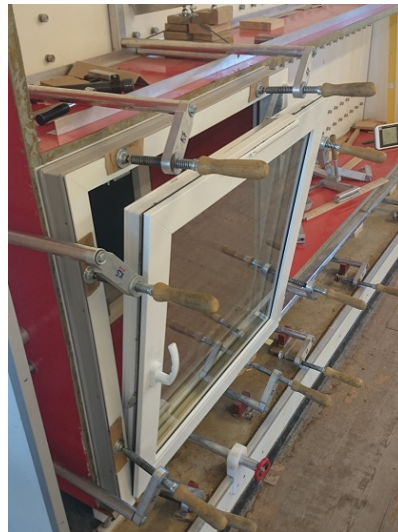
View from inside

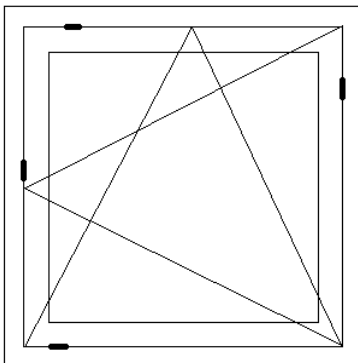
Location of fixings (view from inside)
